Cause Of And Solution For Cable Generated Noise In MEMS Accelerometer Signals

By Dr. Patrick L. Walter, *Texas Christian University*

CAUSE OF AND SOLUTION FOR CABLE GENERATED NOISE IN ACCELEROMETER SIGNALS

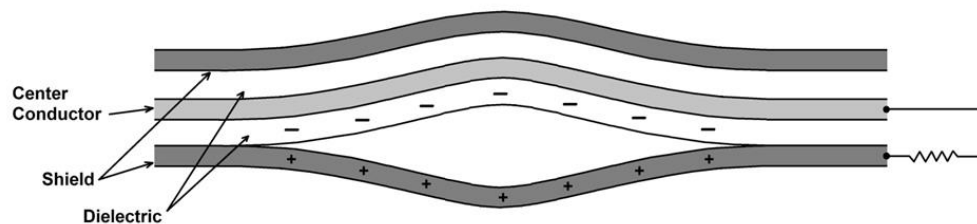
Figure 1. Charge Generation within a Coaxial Cable

TRIBOELECTRIC EFFECTS IN PIEZOELECTRIC ACCELEROMETER SIGNALS: Signal generation within a cable (as opposed to cable pickup) attributable to triboelectric effect has long been known to occur in the output from piezoelectric sensors (force, pressure, acceleration transducers) operating in a charge mode (i.e., without contained electronics (non ICP® or non IEPE)). For this effect to occur there must be cable motion. Since all instrumentation cables are combinations of metal conductors, inner dielectrics, metal shields, and outer jackets of differing materials, it would be expected that any motion of the cable would result in some triboelectric effect (signal generation). As it is associated with piezoelectric accelerometers this motion has traditionally been attributed to cable vibration. Figure 1 shows one example of this charge generation within a coaxial cable.

Examining Figure 1, during cable vibration charge builds up due to relative motion between the shield (in this case positive) and the dielectric (in this case negative) due to rubbing. The shield and dielectric separate, and the mobile charge on the shield flows into the charge sensing amplifier resulting in additive noise superposed on the

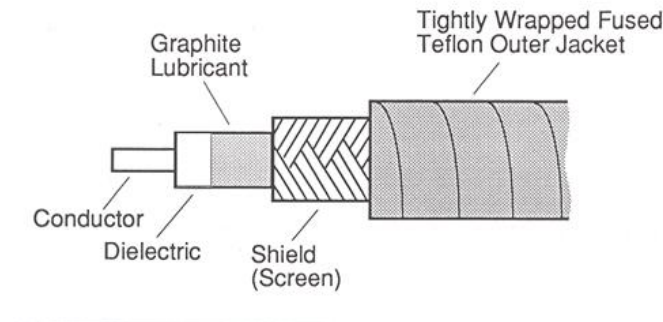
Figure 2. Graphite Treated Low-Noise Cable for Piezoelectric Accelerometers Operated in a Charge Mode

acceleration signal. Under continuing cable vibration different portions of the shield and dielectric open and close and triboelectric induced noise effects become an ongoing, additive contribution to the signal. One contributory solution is to pack all the internal cable interfaces with graphite, which essentially functions as a conductive shunt when the cable materials separate, thus eliminating charge buildup. Figure 2 shows such a graphite lubricant between the dielectric and the shield to minimize triboelectric effects.

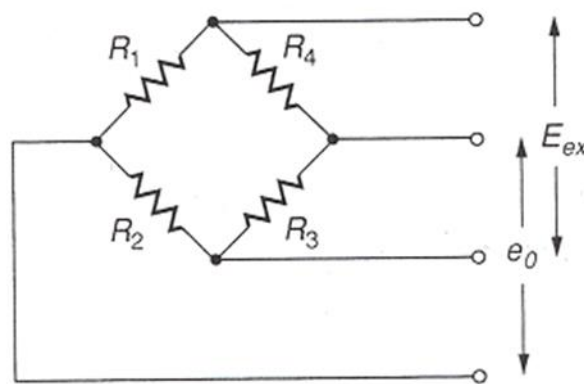
Figure 3. Electrical Model of MEMS Sensing Element

The aerospace industry was the first to recognize the potential destructive effect of pyroshock. The firing of explosive bolts, nuts, pins, cutters, and other similar devices initiated this pyroshock. Subsequently, it was recognized that other environments (e.g., the sudden release of strain energy and metal-to-metal impact), although not initiated by explosive devices, produced effects similar to pyroshock. Because the stimuli that initiate pyroshock are applied instantaneously, the structure's net velocity change is zero. Pyroshock measurements are attempted with both mechanically isolated piezoelectric accelerometer and MEMS accelerometers². The electrical equivalent of a thermally uncompensated MEMS accelerometer is shown in Figure 3 and obviously requires a 4-wire shielded cable (e.g., Figure 4) as opposed to the coaxial cable associated with the charge mode accelerometer.

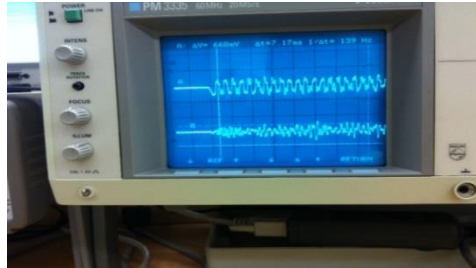
Figure 5. Top Trace Powered Active Bridge; Bottom Placebo Bridge

The initial field test surprisingly showed that both the active strain gage bridges and the placebo bridge produced comparable magnitude signals (Figure 5)!! Possible causes were opined to be: (1) instrumentation amplifier cross talk, (2) unpowered signal generation within the strain gages themselves, and (3) triboelectric generated noise in the instrumentation cables. Initially, triboelectric cable effects were deemed as an unlikely cause due to the low source impedance of the resistive strain gage bridge.

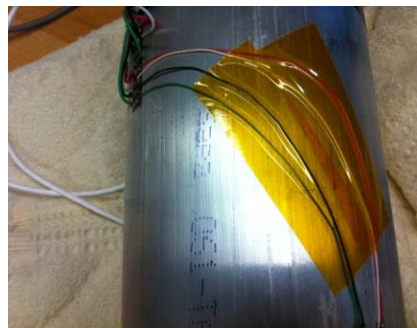
Figure 6: Transitional wiring to 4-Wire Shielded Cable

A mockup of cabling as configured within the frac (perforation) gun was made as shown in Figure 6. Three resultant impact studies determined the existence of a noise source due to a charge/current generation effect in the multicolored (red/black/green/white) transitional wiring to a Belden 4-wire shielded cable. When constrained by the yellow Kapton (Figure 6) tape, traveling waves due to impact of the surface of the perforating gun section would mechanically couple into this wiring. The same results were obtained independent of whether the test item was made of 4340 steel (original material) or aluminum.

The next test series involved replacing the wiring configuration of Figure 6 with Vishay 430 FST cable with the colored wires taped down as shown in Figure 7. The gages shown were physically adjacent but wired separately. There were symmetric gages on the bottom of the instrumented section so each bridge again contained an active 2-arm gage pair. When impacted with no power applied to the bridge it was observed that the triboelectric cable response was somewhat lower in magnitude but still present.

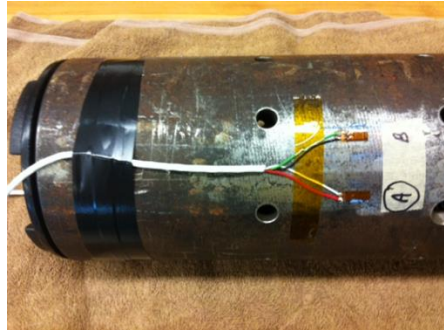
Figure 7: 1000 Ohm Karma Gage Pairs Cabled with Vishay 430 FST Cable

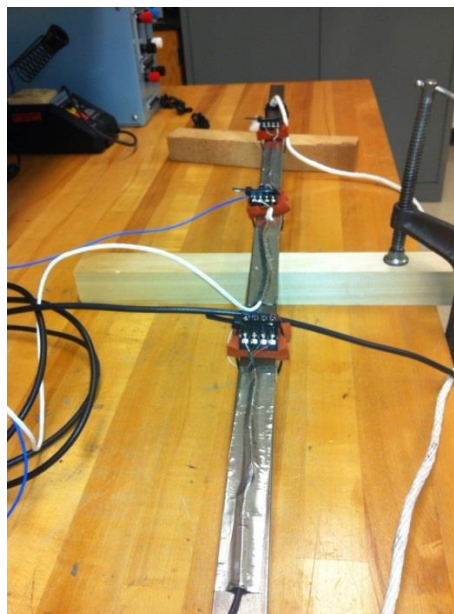
Figure 8. 1 inch by 1 inch Square Hopkinson Bar Used in Testing

SOLUTION INVESTIGATION: The solutions to cable noise attributable to triboelectric effects include, among others: (1) in vibratory environments minimize cable “whip”, (2) in severe mechanical impact environments avoid securing the cable to any structure in such a manner that stress waves couple into it (keep it as free as possible), and (3) use as much graphite as possible as a cable filler between cable constituents. Testing was performed to evaluate these solutions postulates. Figure 8 shows three cables affixed to a long, slender bar with aluminum tape. The cables were identically terminated in both 350 and 1000 ohm metal film resistor bridges that were mechanically isolated from the bar. During the course of testing various types of support tapes were used. Figure 8 shows only one of many test configurations in terms of cable routing. The test bed was a Hopkinson Bar with a 1 inch square cross section and a length/width ratio of 48:1 to assure essentially 1-dimensional wave motion. The bar was impacted numerous times on its end and cable triboelectric responses were monitored.

existing PCB Model 34 cable. Both accelerometers had their cables identically bonded to the 1 inch square 48 inch long Hopkinson bar. The accelerometers themselves were allowed to hang off the bar. With no power applied to either bridge, the results of Figure 9 were essentially replicated. This was as expected.

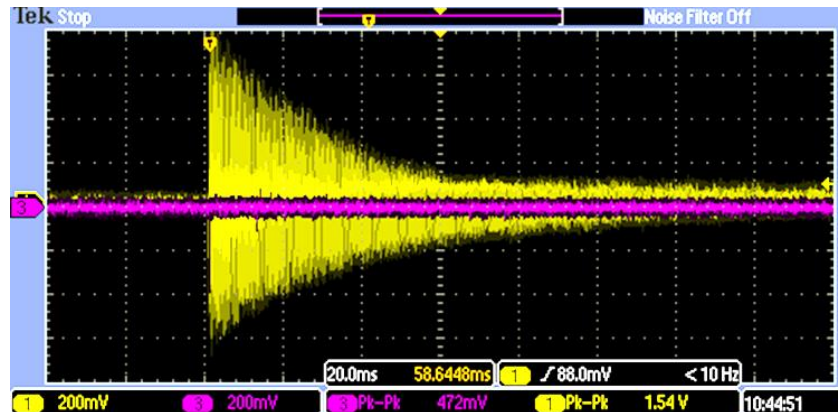
Figure 9: Comparison of Strain Gage Manufacturer's Cable to Special Fabricated Cable

The center (white) cable is Measurements Group 430-FST, a 30 AWG Teflon coated stranded cable with braided shield. Measurements Group is also the strain gage manufacturer. The upper (blue) cable is a PCB-Model 034 teflon-coated, graphite-filled cable. PCB procures this model cable from an external source. This cable was observed to produce lower noise levels in laboratory and field testing, but was harder to work with since it had solid 34 AWG wiring. The lower (black) cable was a special silicone rubber coated cable manufactured special for the author. As noted, the cables were terminated in resistive bridges that are totally strain isolated from any mechanical input. Figure 9 shows one set of comparative test results (special black cable (purple trace)) to Measurements Group (white cable (yellow trace)) when the bar was impacted on its end. Both cables shown are the same AWG wiring. Among other things the special cable is packed full of graphite. The graphite has minimized signal generation since it conducts electricity and helps preclude charge generation between conductors. In every test the special (black) cable generated the least triboelectric output.

The improved performance in terms of the minimal or almost no triboelectric signal emanating from the specially fabricated cable was expected based on the following research by the author:

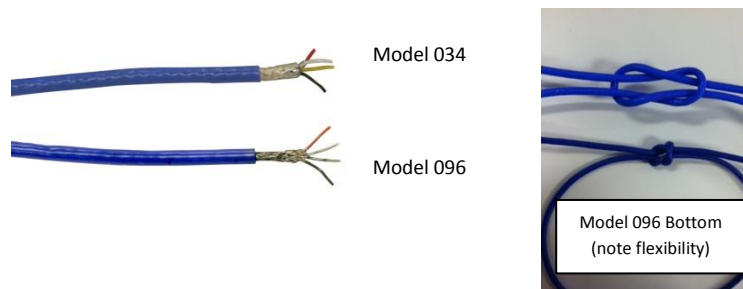
Figure 11: PCB MEMS Cable Model 034 Comparison to New Model 096 Stranded Wire Silicone Rubber Cable

This cable design change is being incorporated into all future PCB MEMS accelerometers intended for pyroshock applications (Figures 10 and Figure 11) reflecting continuous product improvement. In addition to these findings, results of this study indicate that for any accelerometer cable encountering pyroshock one should: (1) minimize cable contact points with the surface being impacted as much as possible and (2) use the minimum hold down surface area.
