Two Parameter Predictive Maintenance Program

An effective vibration monitoring program for
reliability departments with limited resources

James C Robinson
Consultant

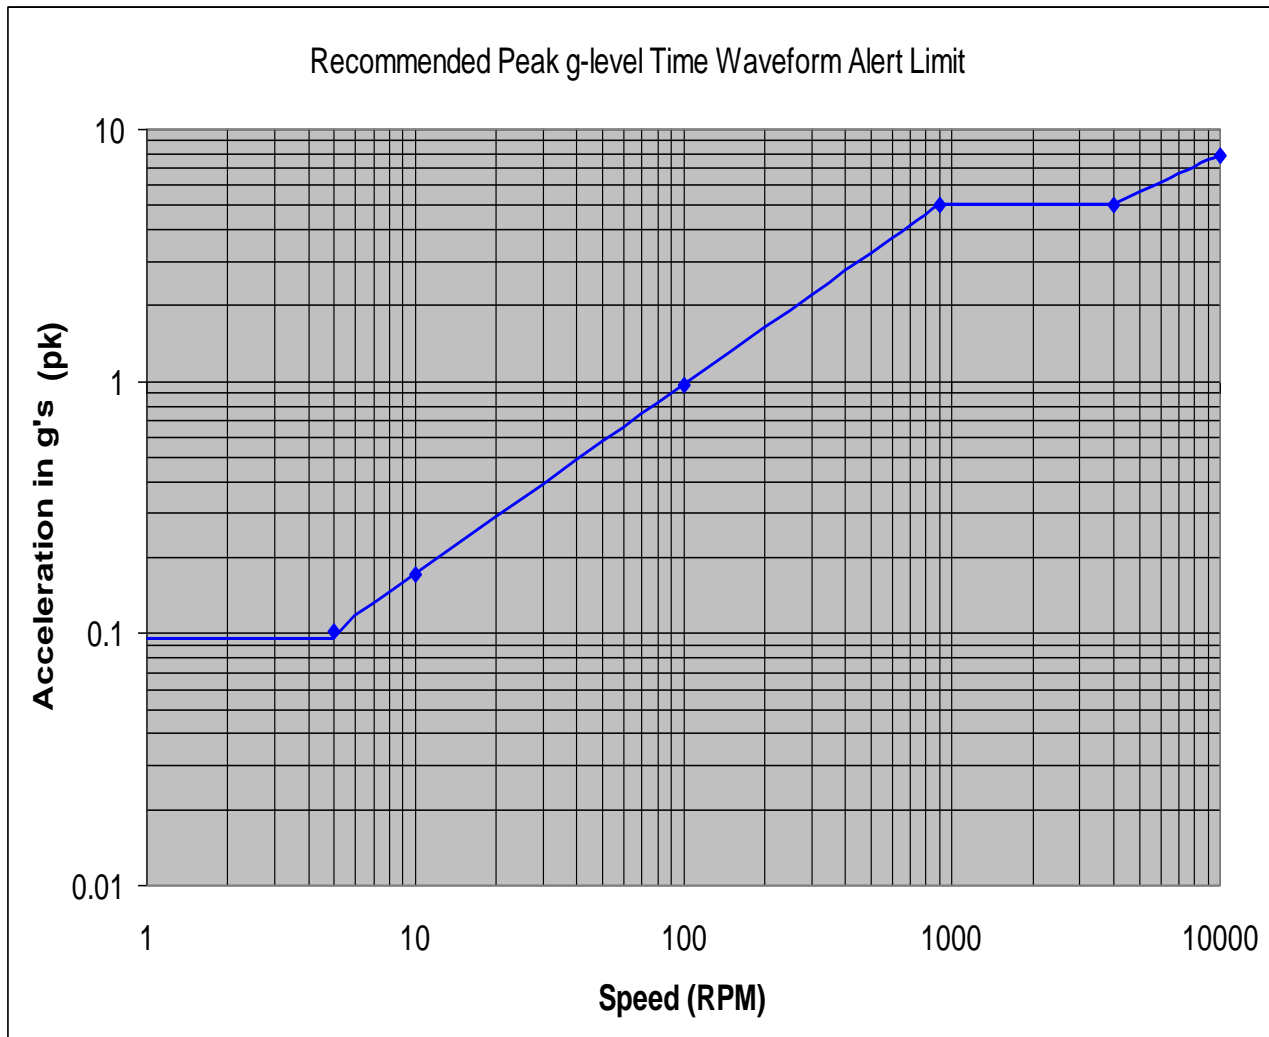
For the high frequency band parameter (absolute peak g-level), a chart for recommended alert levels are presented in Figure 1. These levels are recommended as an initial starting point. Individual experience may warrant refinement. The cases selected consist of a lubrication issue, defective inner race, cracked inner race, balancing problem, and a case where only two overall measurements were used (low frequency RMS velocity and high frequency peak acceleration.)

Figure 1
Recommended alert levels for the absolute peak g-level parameter

The second case is an inner race bearing fault on the output shaft (turning at 156 RPM) of a Hot Mill Pinion Stand Gearbox. Both the high frequency Peak acceleration (g) and the low frequency RMS velocity parameter (ips) were trended over a two-year period. The trend for the high frequency Peak acceleration is presented in Figure 3. For a shaft turning at this speed, the recommended Alert level (see Figure 1) would be set at 1.6 g's. In Figure 3, this level was reached around 600 days into the trend.

The third case is a cracked inner race on a Press Suction Roll in a paper machine running at 220 RPM. For this speed machine, the Alert level recommended in Figure 1 is 2 g's. The peak acceleration spectra and time waveform acquired on June 5, 2003 are presented in Figure 5. The peak acceleration of 14 g's is significantly greater than the recommended Alert level of 2 g's. A picture of the cracked inner race is presented in Figure 6 showing significant damage had occurred.

The RMS velocity trend parameter did not change very much from before until after the bearing change out on January 15, 2013 (Fig. 9). In contrast, the True Peak Acceleration went from a peak of 27 g's prior to bearing change to a quiet 1 g following bearing change out. The fault chart in Figure 1 suggests that an alert level for this speed machinery should be set at 5 g's which is well above the 3 g level in Figure 10 following the bearing change out. A picture of the inner race from the defective bearing is presented in Figure 11.

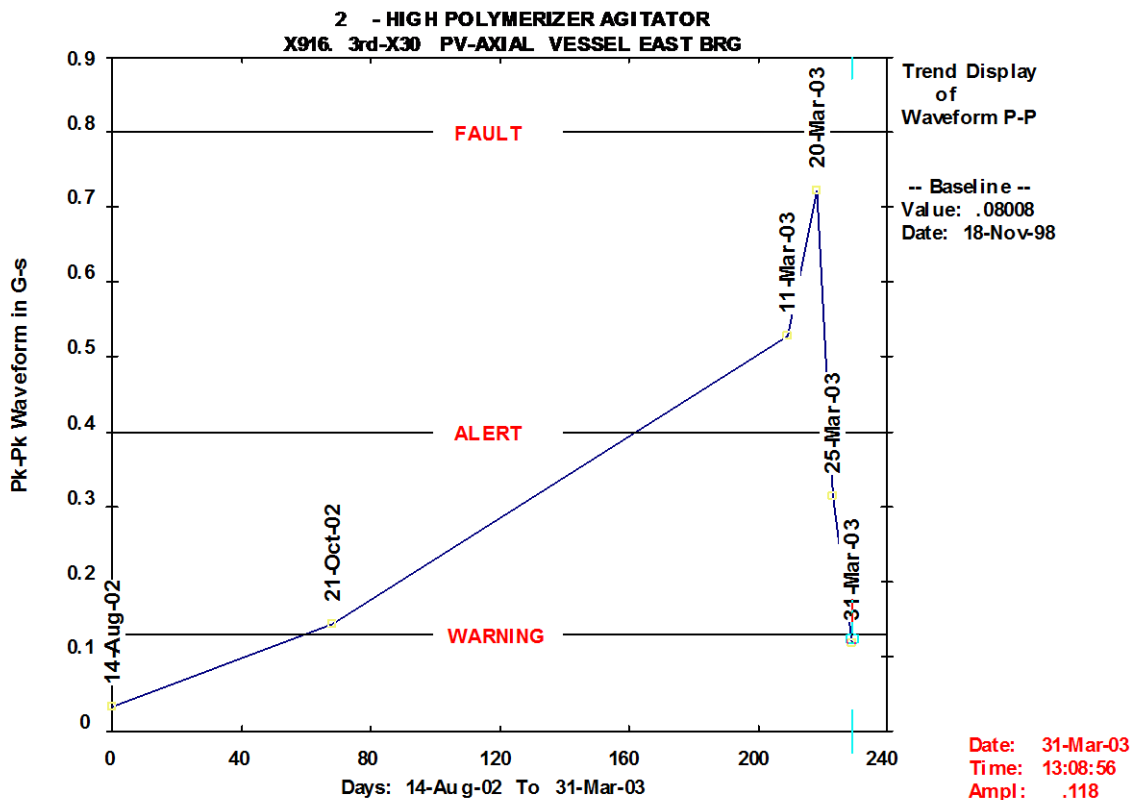
The first case is a High Polymerize Agitator that turns at 10 RPM. During an outage, one of the maintenance tasks was to clean out the grease packed bearings and repack them with fresh grease. The machine was placed in the outage on October 21, 2002 and returned to service in March 2003. A trend plot of the absolute peak g-level (each peak reading was observed over 2.6 Revs) is presented in Figure 2. The absolute peak g-level was below the Alert level of 0.2 g's prior to the outage (see Figure 1 for recommended alert level). Following the startup, the Peak g-level was near 0.5 g's, which indicated a fault was present. This initiated the diagnostic team to identify and correct the fault. By the time the probable cause of the fault was identified as the lack of lubrication (perhaps bearing was not repacked in grease), the Peak acceleration had Increased to about 0.7 g's. At that point, grease was added to the bearing until the Peak acceleration returned to the level that was present before the outage around 0.2 g's.

Figure 2
Trend plot of the absolute peak g-level for the Polymerize Agitator

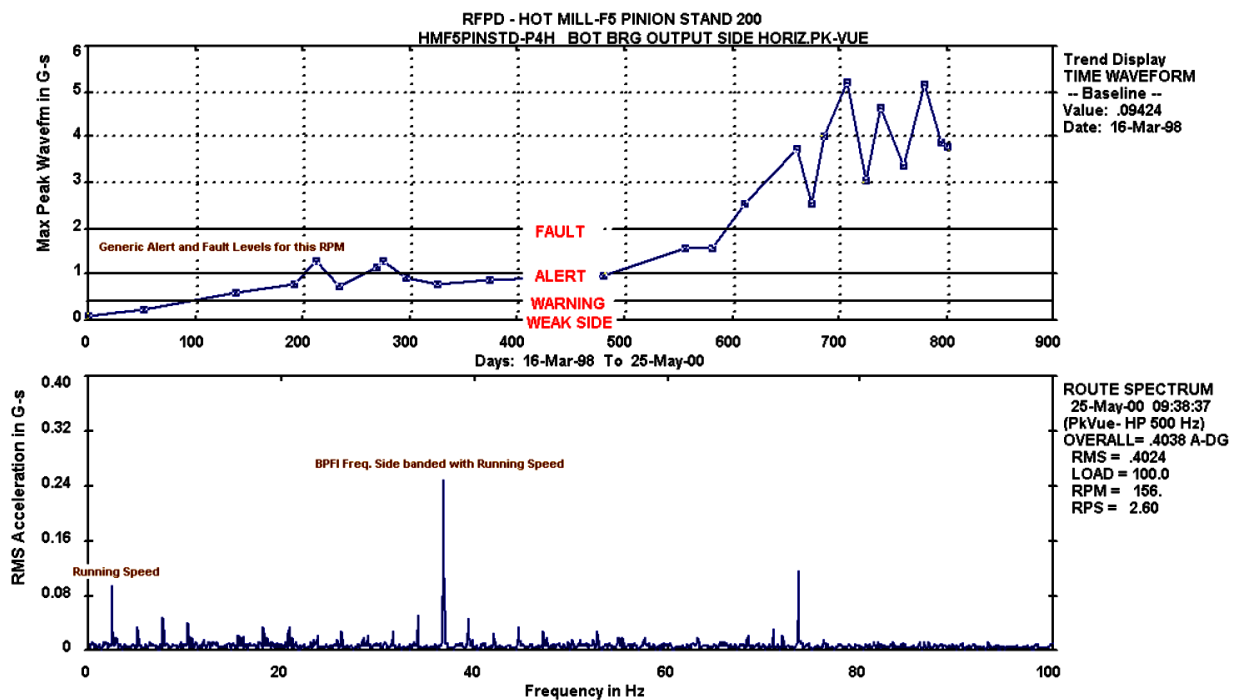
Figure 3
High frequency Absolute Peak g-level parameter trend
as well as the Peak g-level spectral data

The spectral data in Figure 3 identifies the fault as an inner race fault. The low frequency RMS velocity was also trended over the same time. It remained reasonable constant fluctuating around 0.03 ips for the entire 800 days of observation. The bearing's inner race (Fig. 4) as found to be severely cracked and replaced. The trend parameters returned to their original low levels following bearing replacement.

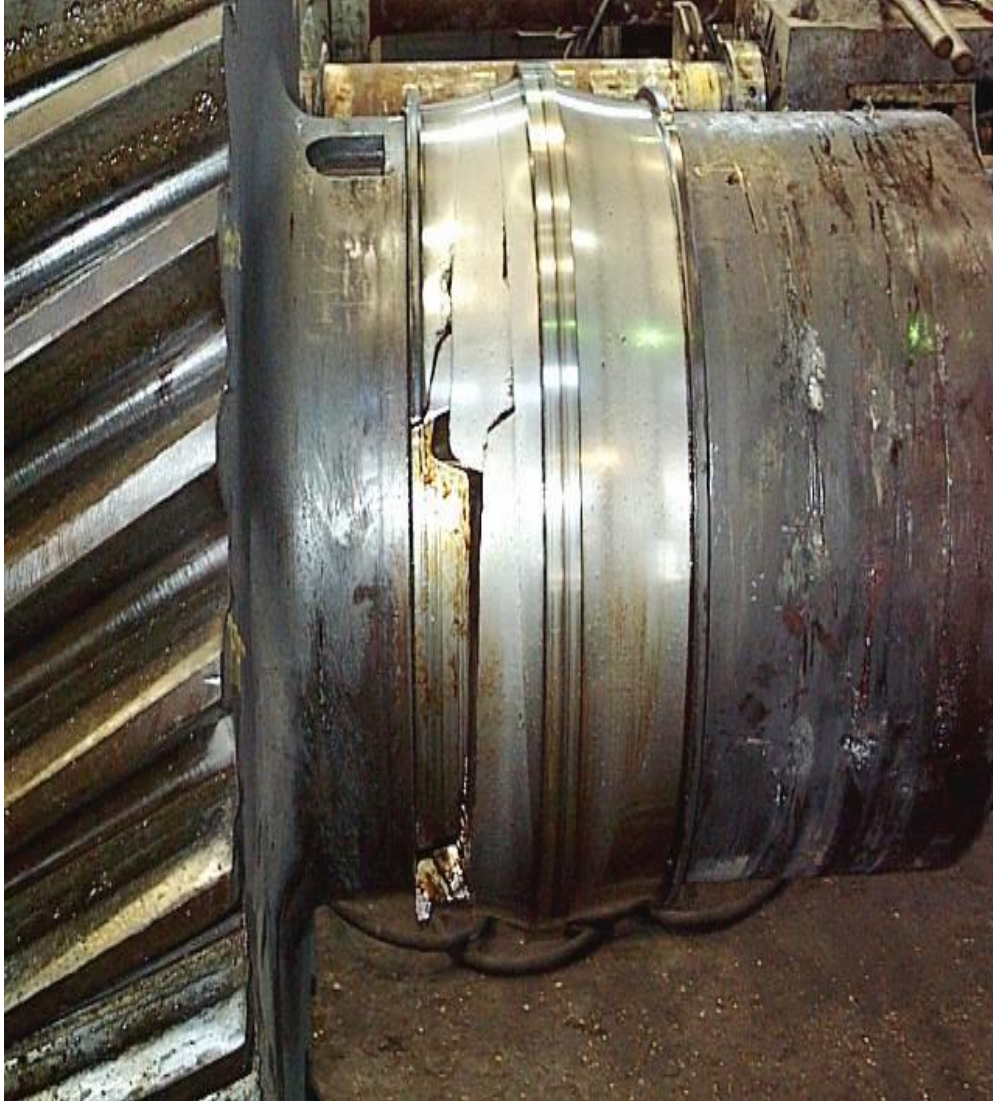
Figure 4
Picture of defective bearing from the Hot Mill Pinion Stand Gearbox

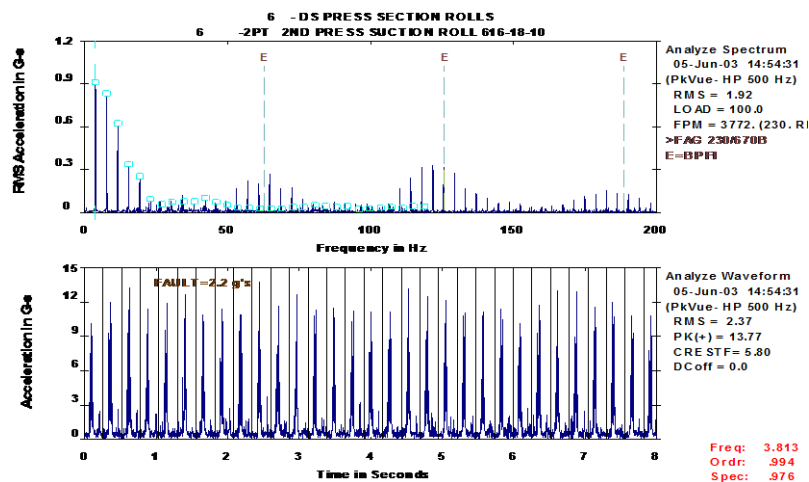
Figure 5
Peak g-level spectra and time waveform in peak g's from the Press Suction Roll acquired on June 5, 2003. The peak g-level is 14 g's.

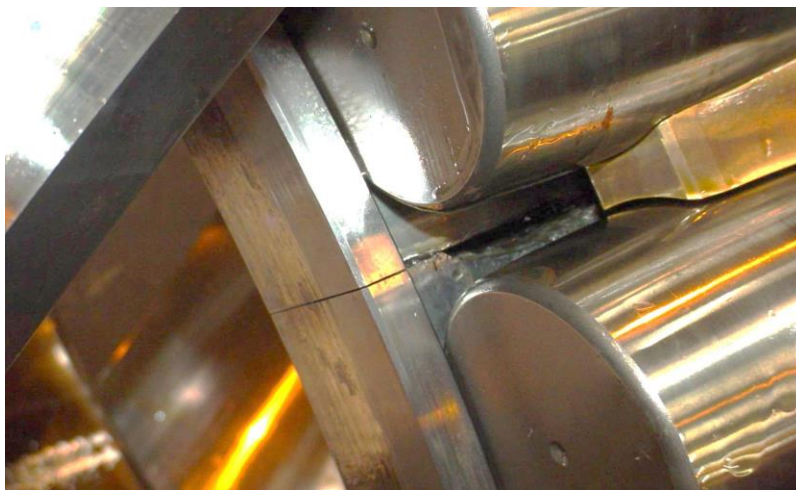
Figure 6
Picture of the Bearing with cracked inner race from the Press Suction Roll

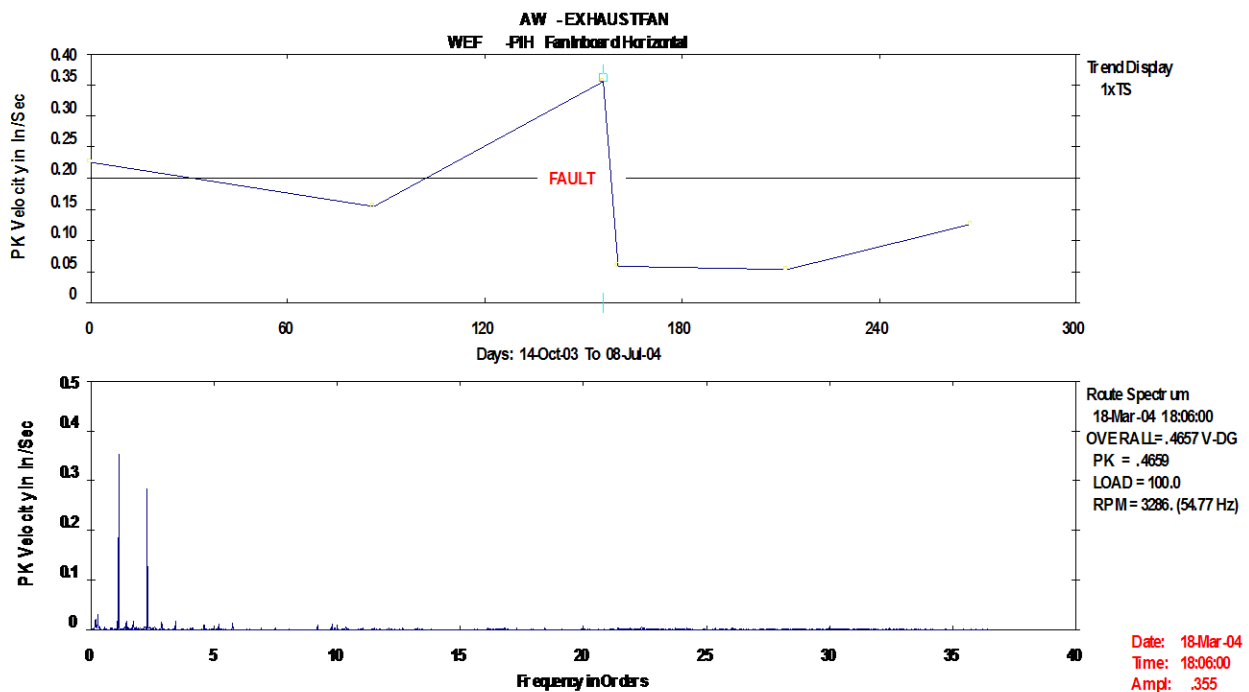
The fourth case is for a high-speed fan (3300 RPM) with a balancing issue. The velocity vibration data (trend and spectra data) are presented in Figure 7. The trend data covers a time of one year. The trend of the peak velocity (units of ips) shows a peak of around 0.35 ips occurring on March 18, 2004. The spectral data presented in Figure 7 is at the time when the peak in the trend occurred. The only activity in spectral data is at one and two times the fan running speed (typical for a machine running out of balance). The trend of peak g-level and spectra from the high frequency data are presented in Figure 8. The suggested Alert Level from Figure 1 for this machine is 5 g's. The conclusion from the data presented in Figures 7 and 8 is the low frequency band velocity data are sensitive to balancing issues but the high frequency data are not.

Figure 7
Spectra and Trend Low Frequency Velocity Data from High Speed Fan

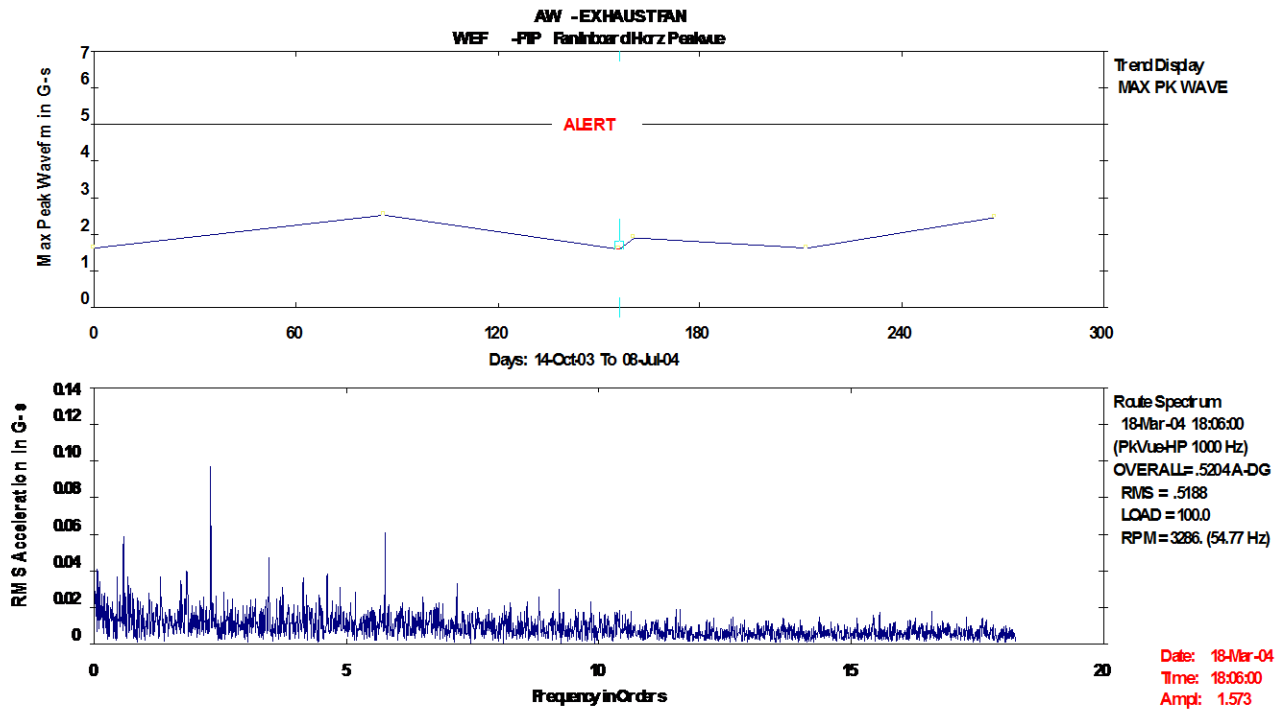
Figure 8
 Spectra and Trend High Frequency Peak g-level from High Speed Fan
 (same machine and time as that in Figure 7)

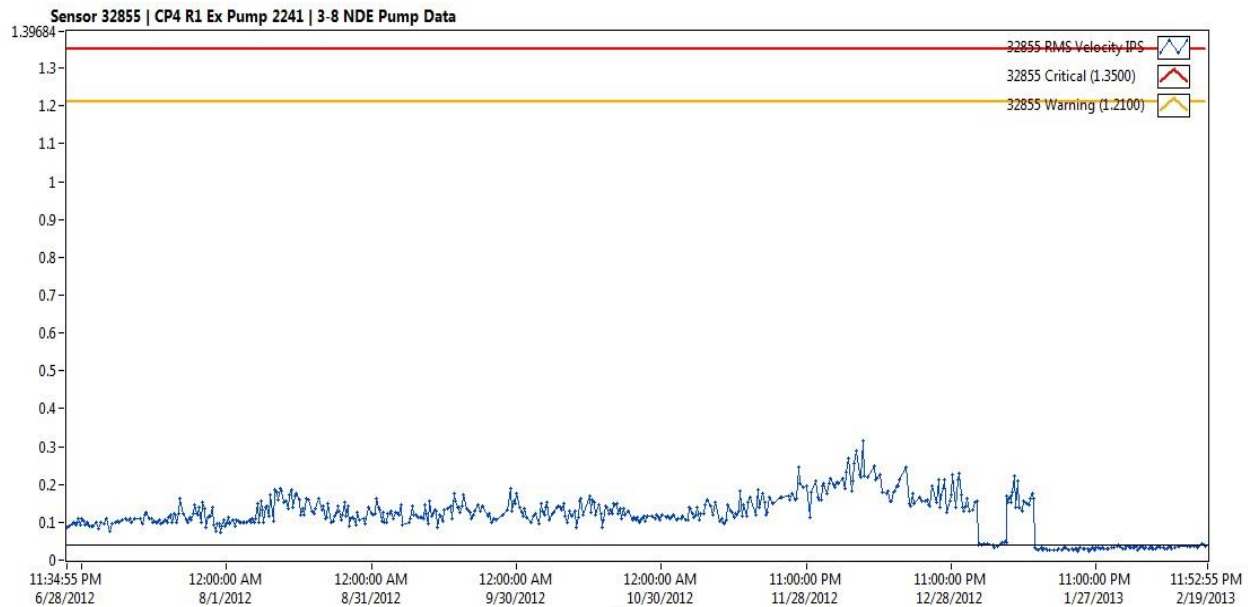
Figure 9

The fifth case is from a standard accelerometer (IMI Model 603C01) mounted on a centrifugal pump. The sensor was connected to an EchoPlus® Wireless Junction Box (IMI Model 672A01). RMS Velocity and the True Peak Acceleration are two parameters computed within the junction box, periodically at time intervals preset by the user. The parameters are then transmitted wirelessly from the junction box to a central receiver and data collection software. The overall velocity parameter data are presented in Figure 9. The trend window is about 6 months. The dropout was when the machine was shut down for bearing replacement.

Trend data for the RMS velocity parameter on the centrifugal pump over 6 months

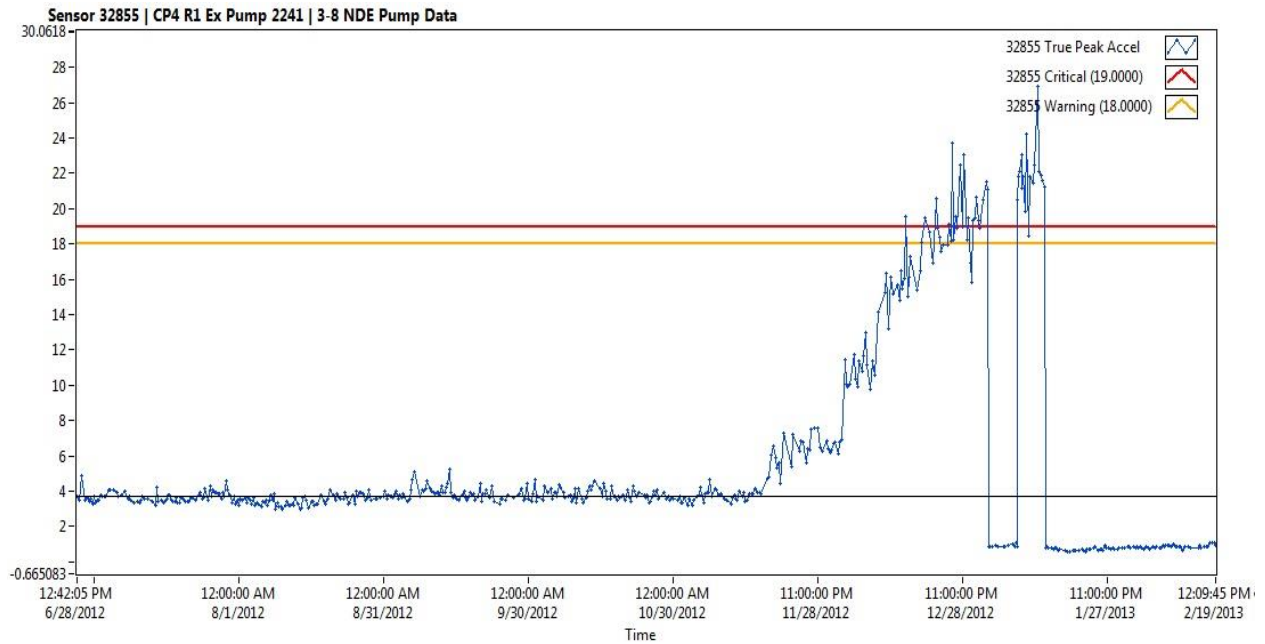
Figure 10
Trend data for the Peak g-level parameter from the centrifugal pump over 6 months

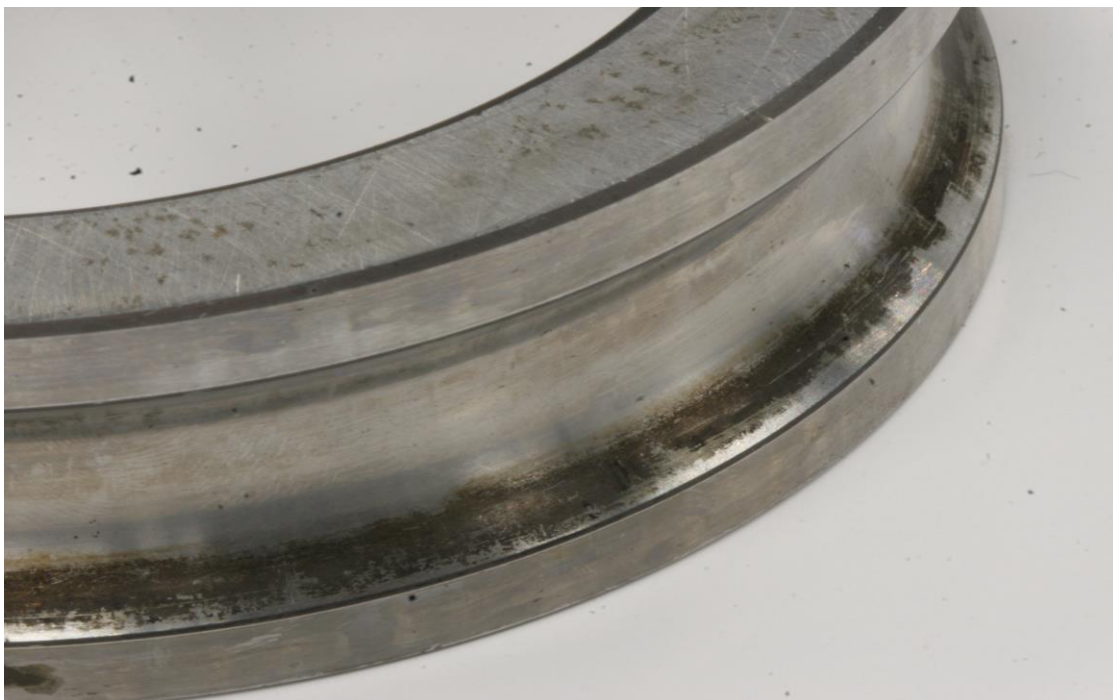
Figure 11
A picture of the inner race of the bearing removed from the centrifugal pump

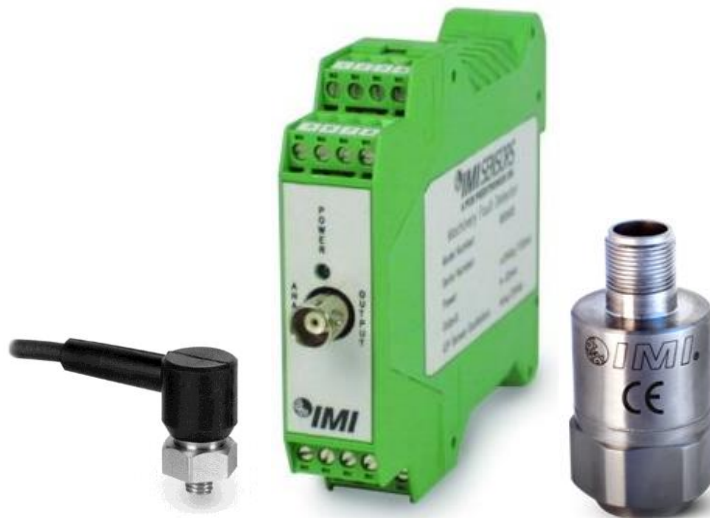
IMI Models 607A11, 682B05, and 649A03

Executing the two-parameter approach does not require a highly skilled vibration analyst team or current advanced equipment employed in the walk-around predictive maintenance program. This method does require a permanently mounted accelerometer at each monitoring point. IMI carries an extensive inventory of low cost industrial accelerometers (603,607 and 608 series). Once the sensors are mounted, there must be a way to forward the status of each to appropriate staff. IMI Sensors offers a 4-20 mA Transmitter (682B05) specifically designed for Bearing Fault Detection. This unit can be connected to any standard ICP® accelerometer and provides both an overall RMS velocity and True Peak acceleration signal for communication with a PLC or DCS. Its RMS measurement covers the Low Frequency band at 10-1000 Hz, and its True Peak measurement covers the High Frequency bandy at 1 or 5-100 kHz (depending on internal settings.) The 682B05 Bearing Fault Detector also has a third output for the raw acceleration signal, which is useful for detailed diagnostics with a data collector.

IMI Sensors also offers the Bearing Fault Detector Plus (model 649A03), which combines filtered transmitter electronics and accelerometer into one small package. This unit can be mounted directly to the bearing housing and connected to a PLC or DCS. Although it can only output one measurement at a time, this unit has 5 measurement options: RMS acceleration, True Peak acceleration, Compensated Peak acceleration (using bearing diameter and speed to normalize output), Crest Factor, and Crest factor Plus (based on original combination of the peak, RMS, and crest factor) for improved detection on variable speed machinery. Similar to model 682B05, model 649A03 has an over RMS acceleration output (high pass filtered at 2500 Hz) and True Peak acceleration output (high pass filtered at 250 Hz.)

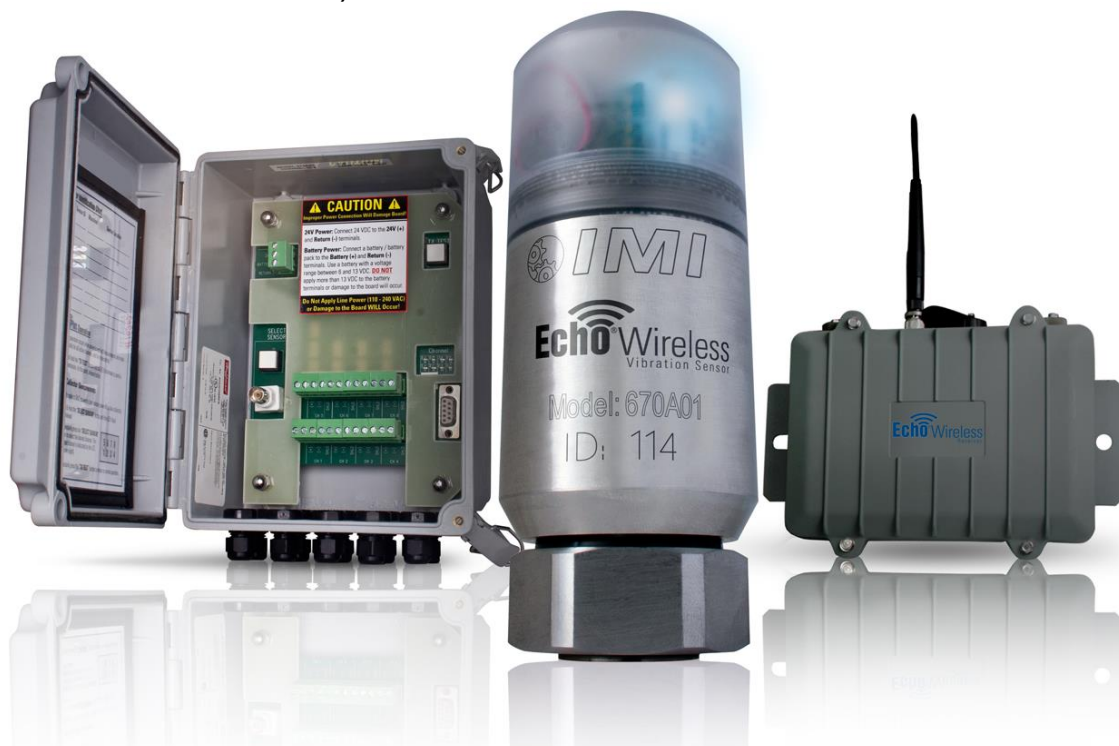
Echo® Wireless Vibration System

Finally, the parameters could be sent back via the IMI Echo® Wireless Vibration Monitoring System. The strength in Echo® lies in the transmission range you can have between the sensor and the receiver. It can transfer vibration measurements across a distance of 2500' to ½ mile in typical industrial environments. This narrow bandwidth system allows for vibration monitoring of hundreds of points across an entire plane; however, it has limited data transfer rate. Therefore it is not practical to send the raw vibration waveform data back using Echo®, but the periodic filtered measurements work perfectly with the Two Parameter method.

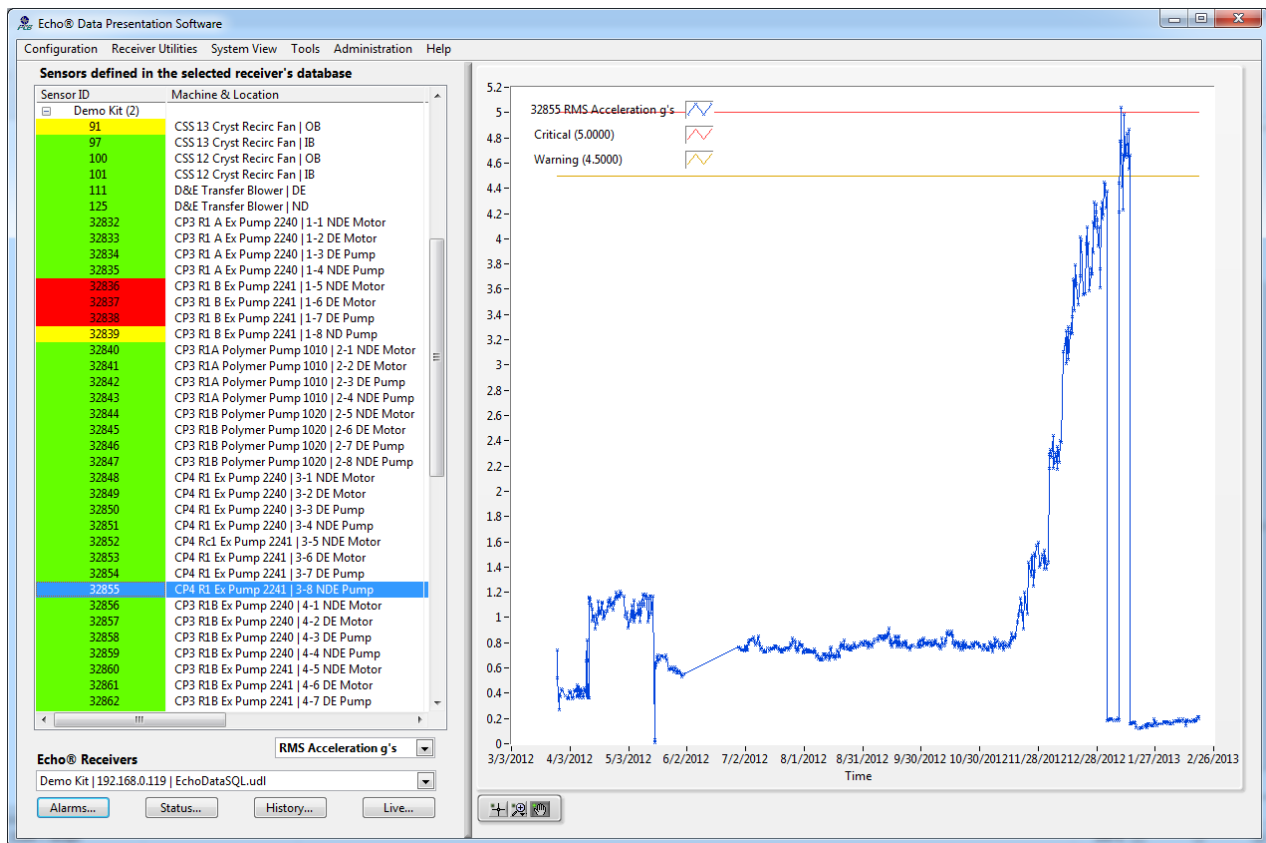
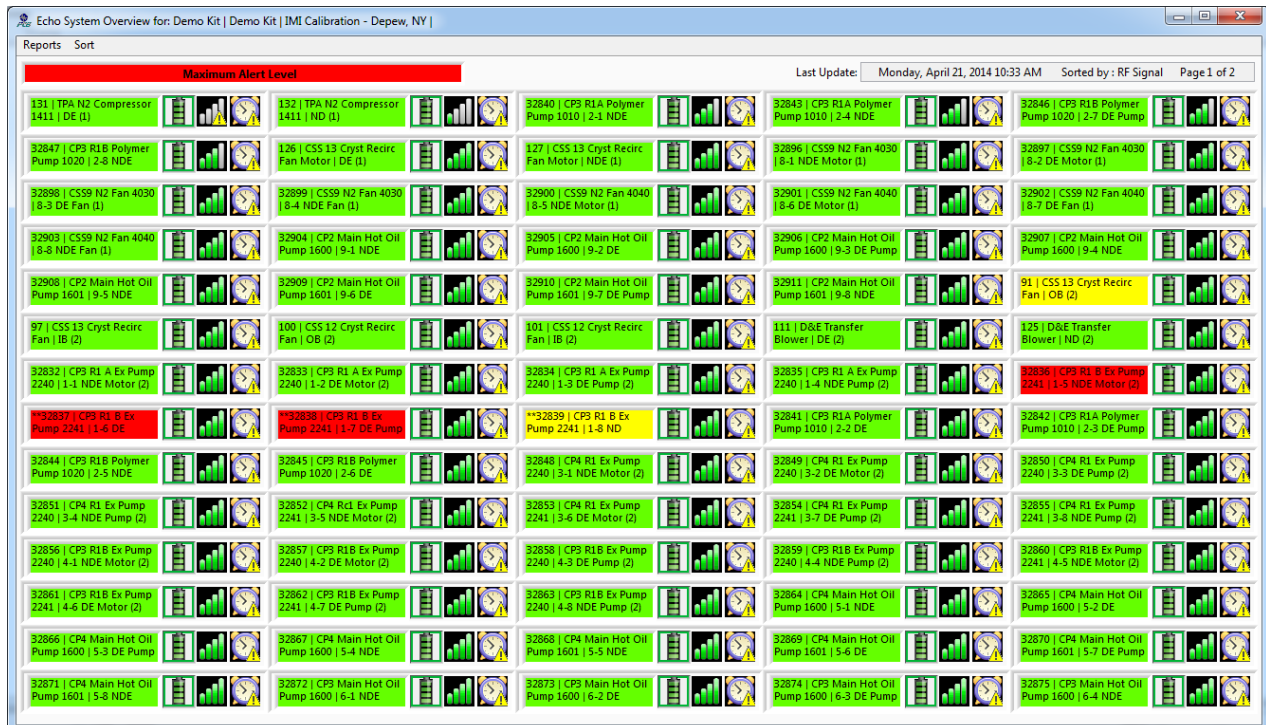
Echo® Wireless Vibration Monitoring Software
 Trend Plot (Above) and System Overview with Alarms (Below)

As seen in Case 5, both low frequency and high frequency faults can be measured accurately and detected early using the Two Parameter method with the values transmitted by the Echo® Sensor and EchoPlus® Junction Box. This allows a Predictive Maintenance program to efficiently operate and only focus on full spectrum data collection and analysis when necessary. Using the Echo® software pictured above, condition monitoring can be done at-a-glance with the various vibration trend plots and alarm panels.
